Summary of GMD Shipyard Activity to meet EPA requirements as the end of August 2014:

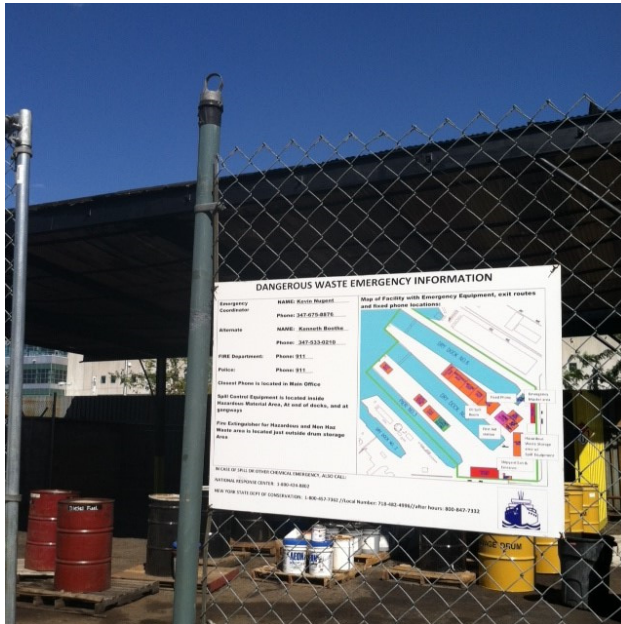
Photo 1

Entrance to Hazardous Waste and Non Hazardous Waste Drum Area

6. During the time period 21 – 28 August the following yard improvements have taken place:
 - a. The drum area roof has been repaired so that there are no leaks. The supports have been inspected cleaned up and repainted. See photos 1, 2, 3 & 4

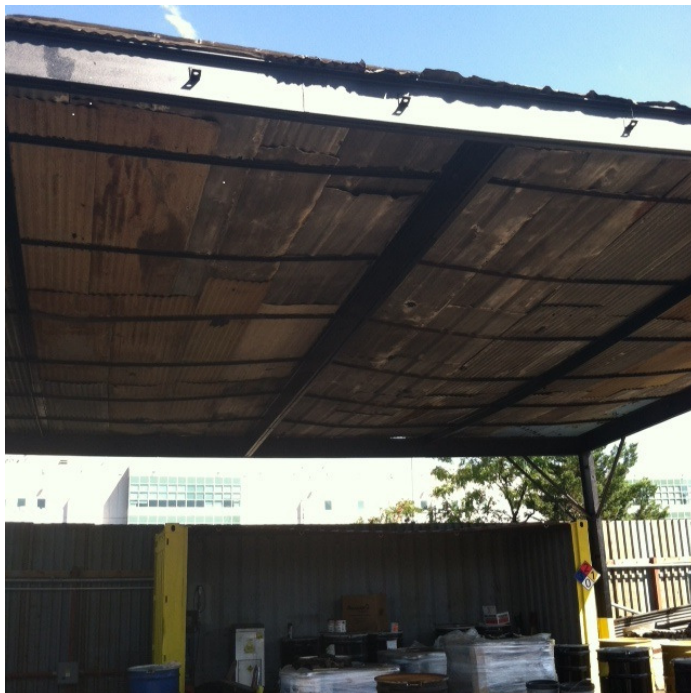
Photo 2

Shows midsection of underside of Hazardous and Non Hazardous Waste Storage area

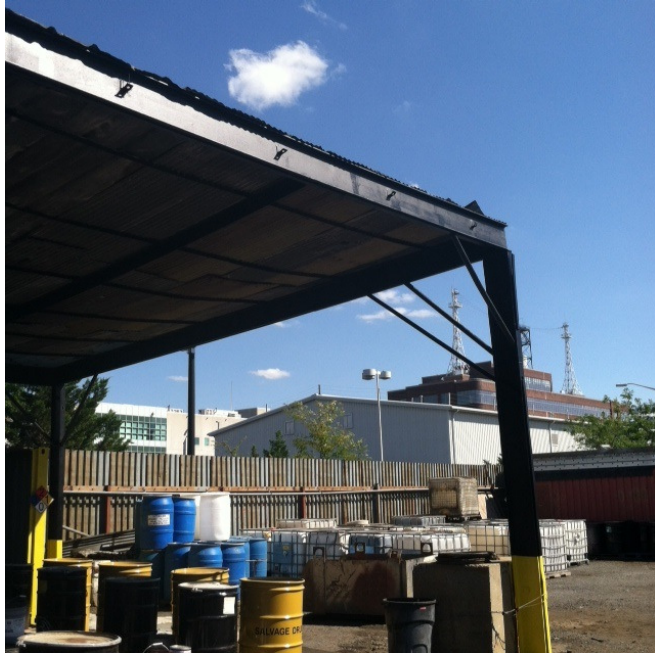
Photo 3

Shows underside of south side area and beams that have been painted

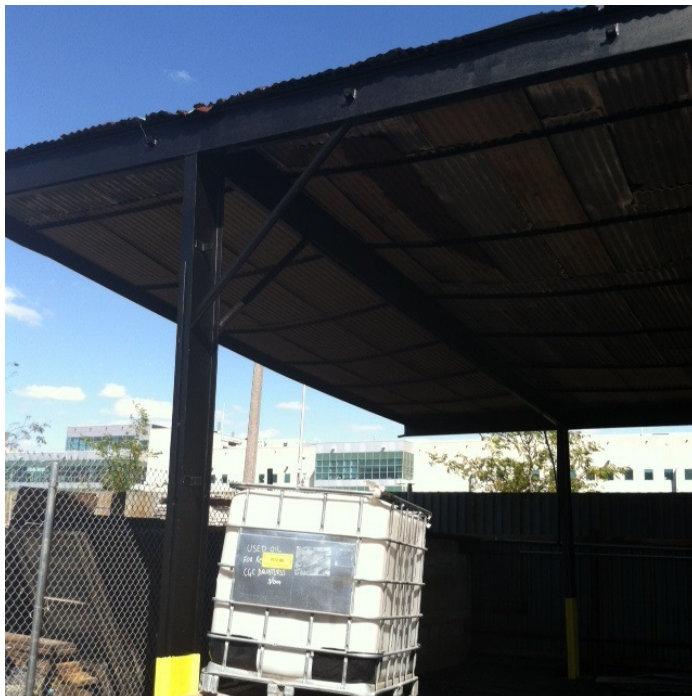
Photo 4

Drum area overhead north side and painted beams

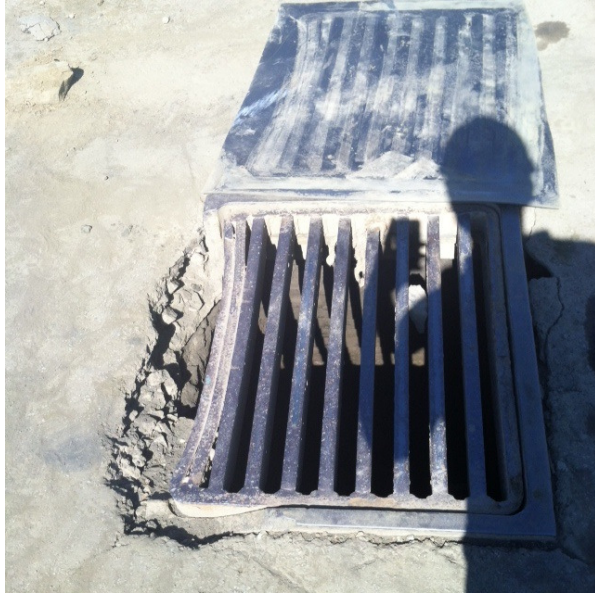
Photo 1 – Drains

This drain section is one near the start of the line of drains making up Stormwater Outfall 004, note the rubber sheet that will be covering it.

- d. The yard storm drain system is being cleared and opened up for proper drainage. See drain photos, 1, 2 and 3 for typical cleared drains.
7. Have also been in contact with NYS DEC concerning getting a specific SPDES permit for discharge allowing painting and blasting other than the NYS Generic Permit. NYS DEC will be sending me information to file for this permit.

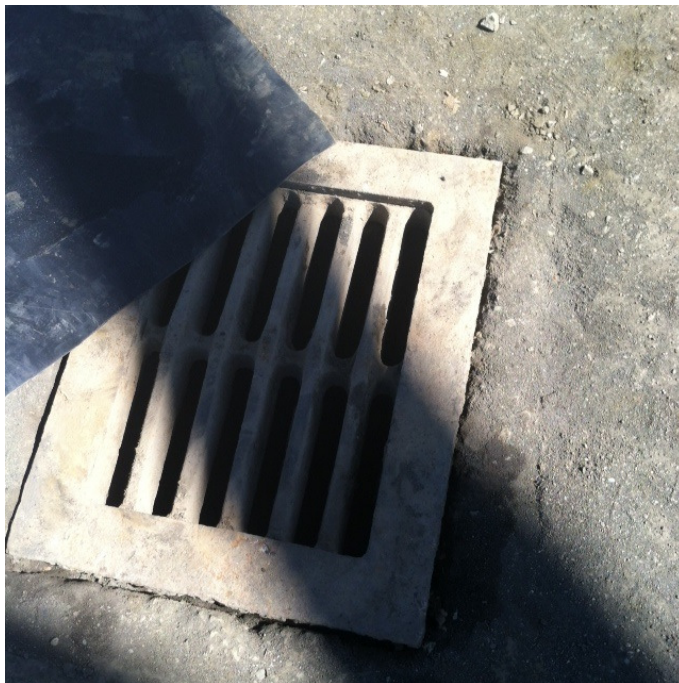
Photo 2 - This is another storm drain in the same system as the drain in Photo 1 also note rubber mat cover

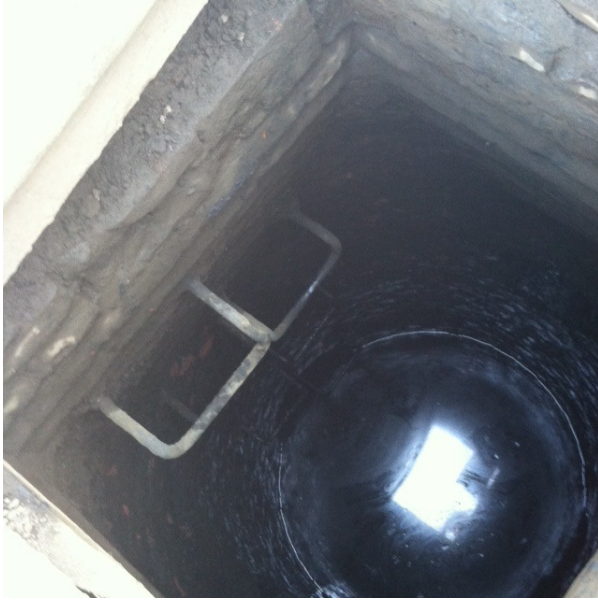
Photo 3 – Drain system

Close up of a typical cleaned out storm drain with a little water in the bottom
